Manhole Inspection Summary

Manhole # S45EE_013MH

Insp Date: **12/20/07 12:52 PM**

Location Address: **chase-eager**

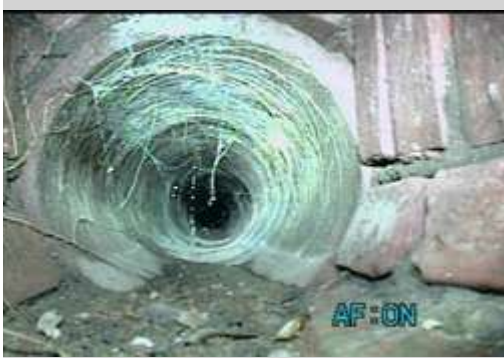
Defect 1

Condition: ☐ Sound ☐ Cracked ☒ **Root Intrusion** ☐ Deteriorated ☐ Leaks ☐ Debris

bench & channel roots

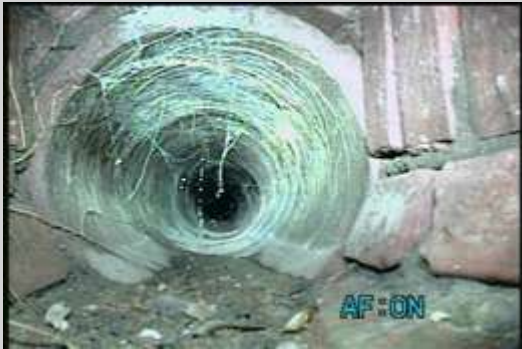
12 O'Clock Outflow

8 in. Circular Gravity Sewer
Pipe Out @ 12 O'Clock

Pipe Material: **Clay** ☐ Pipe Lined

Invert Depth: **9.20** (ft.) Flow Characteristics: **None**

Deposits: ☒ None ☐ Mud ☐ Sludge ☐ Debris ☐ Grease

Infiltration: **None** Pipe Seal Cond: **Unknown**

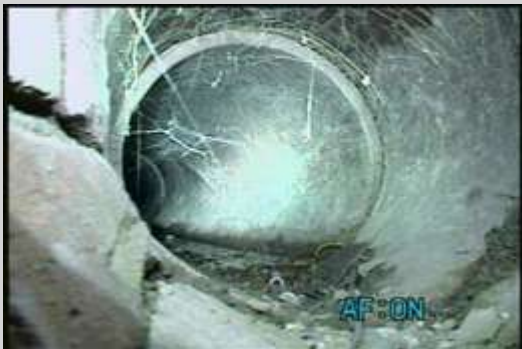
3 O'Clock Inflow

8 in. Circular Gravity Sewer
Pipe In @ 3 O'Clock

Pipe Material: **Clay** ☐ Pipe Lined

Invert Depth: **9.00** (ft.) Flow Characteristics: **None**

Deposits: ☒ None ☐ Mud ☐ Sludge ☐ Debris ☐ Grease

Infiltration: **None** Pipe Seal Cond: **Unknown**

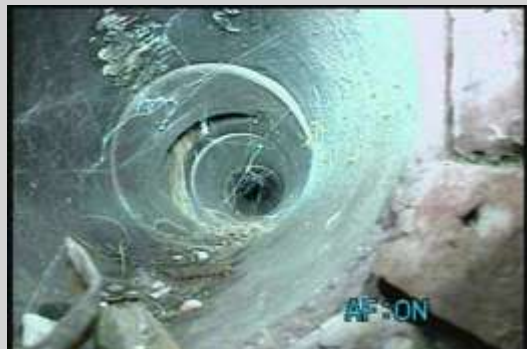
9 O'Clock Inflow

8 in. Circular Gravity Sewer

Pipe In @ 9 O'Clock

Pipe Material: **Clay** ☐ Pipe Lined

Invert Depth: **9.00** (ft.) Flow Characteristics: **None**

Deposits: ☒ None ☐ Mud ☐ Sludge ☐ Debris ☐ Grease

Infiltration: **None** Pipe Seal Cond: **Unknown**
